Swings and roundabouts

First Chris Horton had a 944S2 to look after, then a 944 Lux (his own), and now there's a second Lux – which disgraced itself by snapping its camshaft drive-belt. Read on to see how Horton fixed that particular problem, and for a brief update on his 1986 car. Photography by Peter Robain and the author

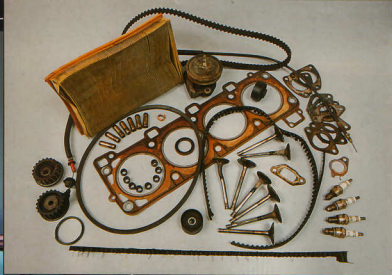
Broken timing belt? Then you'll have to replace most of this little lot, too
